SERVICE LETTER
NON-APPROVED MODIFICATIONS OR
USE OF ROTAX® UNAPPROVED ENGINE
COMPONENTS OR ACCESSORIES
FOR ROTAX® AIRCRAFT ENGINES

SL-912-014 R2

SL-914-012 R2

SL-2ST-008 R2

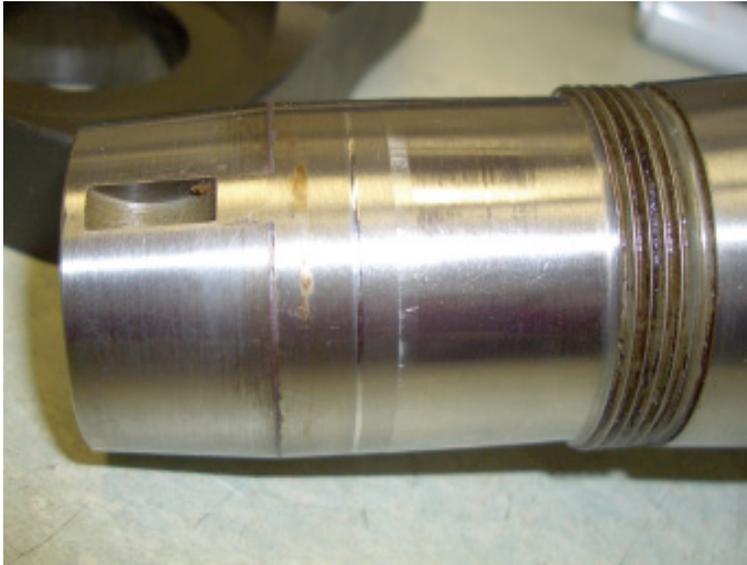
fig. 1

- The crankshaft has a ROTAX[®] part no. 888164 and a serial number (S/N) of S/N 11798, but was not marked as overhauled and shows some serious deficiencies:
 - signs of corrosion in the area of the oil seal (see fig. 1)
 - crankshaft was beyond the out of round limit
 - torque at twist test was below limit
 - a conrod bearing shows signs of wear (see fig. 2)
 - contamination in the oil channels (see fig. 3)

Such a crankshaft is not airworthy and should not be installed or any parts reused according to ROTAX[®]-instructions.
